AIR CONDITIONING AMPLIFIER ASSY

55126-01

REPLACEMENT

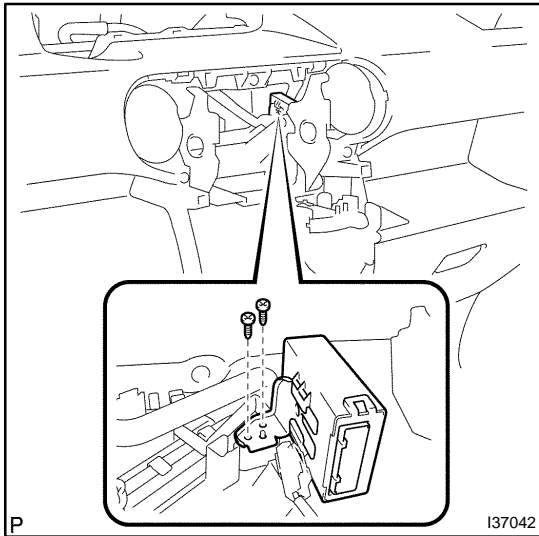
4. REMOVE AIR CONDITIONING AMPLIFIER ASSY
 - (a) Disconnect the connector.
 - (b) Remove the 2 screws and air conditioning amplifier assy.
